MICROSTRUCTURE STUDIES OF REFRACTORY

POLYCRYSTALLINE OXIDES

SUMMARY REPORT

AVCO CORPORATION
Systems Division
Lowell, Massachusetts 01851

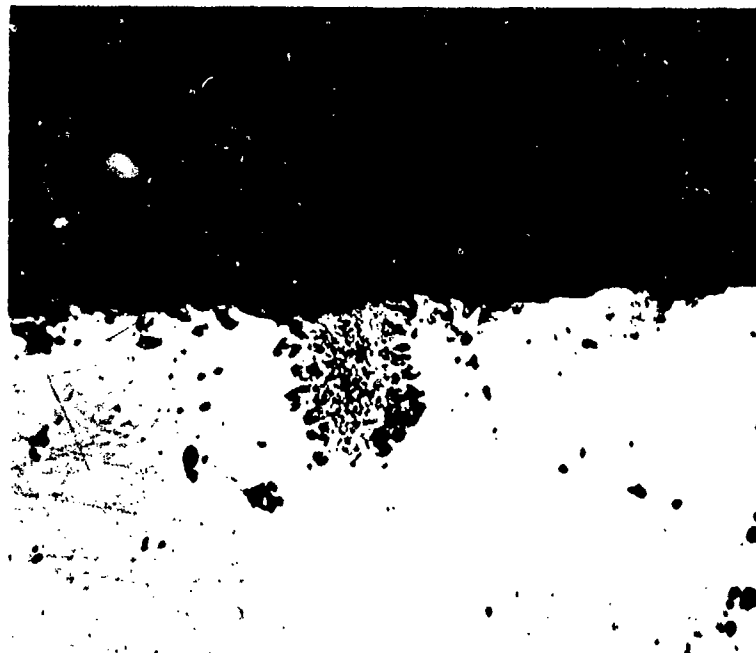
Figure 14. a) Fracture face in billet 642-2 of specimen having oblong flaw, and b) polished face normal to fracture face.

Billet 642 had a high incidence of oblong fine grained defects at the fracture origin. Figure 14a illustrates a macroscopic view of specimen 642-2. At higher magnifications, the fracture surface was indistinct, so the tensile surface was polished to intersect the flaw. Several specimens with similar flaws were polished before obtaining a suitable polish. Figure 14b illustrates the appearance of the flaw, and one is illustrated similar in appearance to that shown in Figure 14a. The area having the appearance of $\frac{1}{2}$ of an oval is the flaw origin. The edge was difficult to prepare, thus it is uncertain whether or not the area was porous; there is a strong possibility that this is the case. Figure 15a is a polarized light photomicrograph of the same flaw shown in Figure 14b clearly outlining the extent of what can be identified as a second phase. Further evidence for a second phase is shown in Figure 15b where this area was lightly etched with phosphoric acid. The second phase zone has been selectively attacked leaving a few lightly etched grains of the second phase and a matrix that is virtually unetched. Thus the defect appears to have a chemical origin and is not related to the fine grain unbonded regions shown in Figure 8.

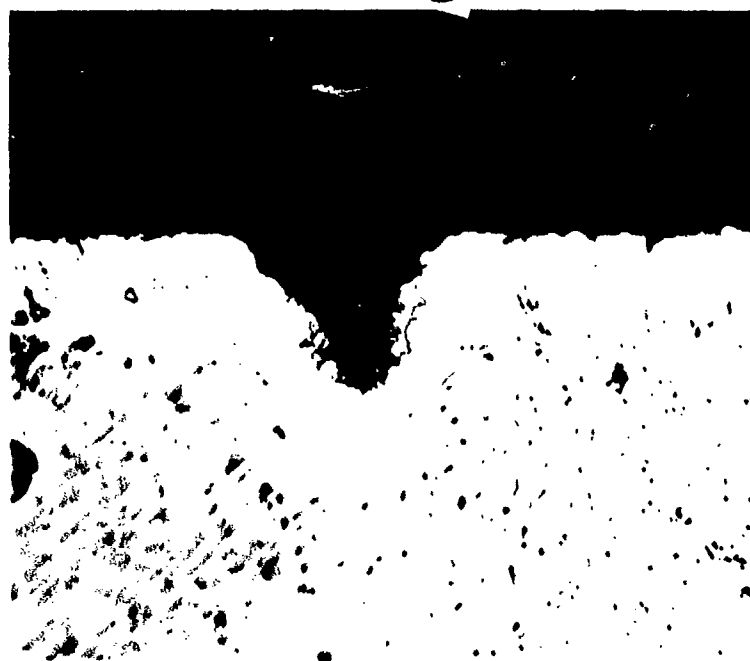
Figure 15. Section normal to fracture face on 642-oblong patch
flaw viewed a) polarized light, and b) after light etch.

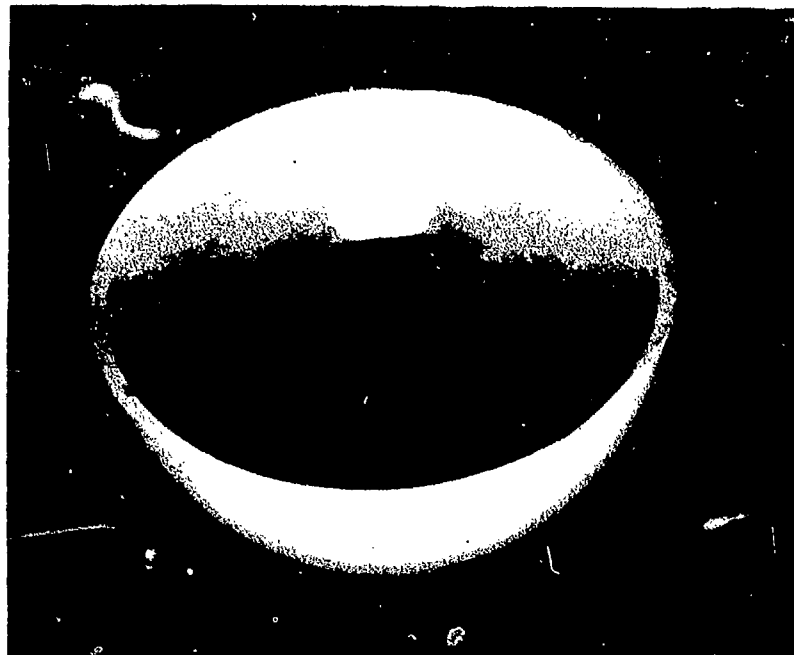
Figure 18. Hemisphere 1577 Press Forged from Solid Right Cylinder.
